Manhole Inspection Summary

Manhole # S53C__007MH

Insp Date: **6/12/08 1:16 PM**

Location Address: **3201 esther place**

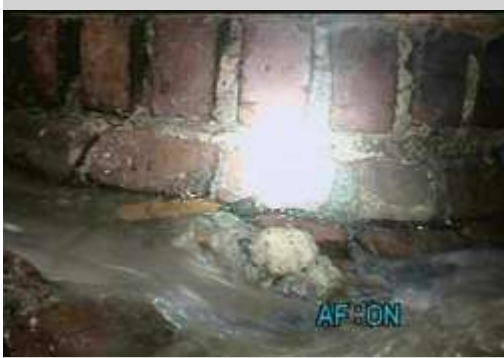
misc

channel debris

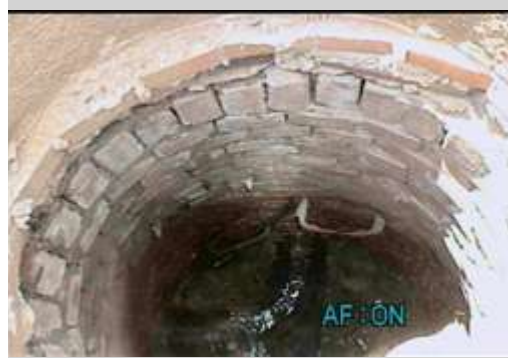
Defect 2

Condition: ☐ Sound ☐ Cracked ☐ Root Intrusion ☒ **Loose Brick** ☐ Deteriorated

Count: **3** Missing: **1** ☒ **Corroded**

corroded steps & lose brick in corbel

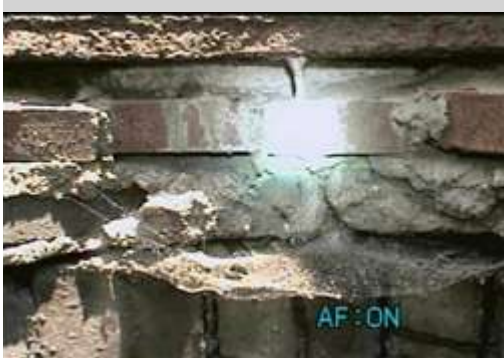
Defect 1

Condition: ☐ Sound ☐ Cracked ☐ Root Intrusion ☐ Loose Brick ☒ **Deteriorated**

chimney deteriorated, frame adj

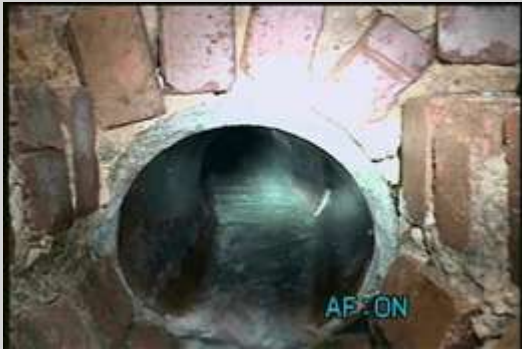
12 O'Clock Outflow

8 in. Circular Gravity Sewer
Pipe Out @ 12 O'Clock

Pipe Material: **Clay** ☐ Pipe Lined

Invert Depth: 9.13 (ft.) Flow Characteristics: **Fast**

Infiltration: **None** Pipe Seal Cond: **Unknown**

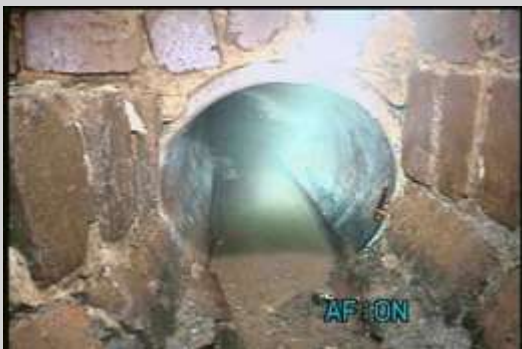
3 O'Clock Inflow

8 in. Circular Gravity Sewer
Pipe In @ 3 O'Clock

Pipe Material: **Clay** ☐ Pipe Lined

Invert Depth: 8.95 (ft.) Flow Characteristics: **Fast**

Infiltration: **None** Pipe Seal Cond: **Unknown**

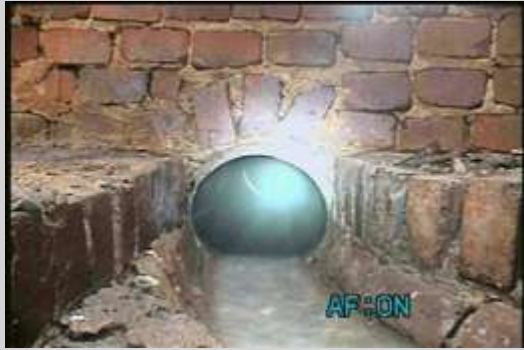
9 O'Clock Inflow

8 in. Circular Gravity Sewer

Pipe In @ 9 O'Clock

Pipe Material: **Clay** ☐ Pipe Lined

Invert Depth: **9.19** (ft.) Flow Characteristics: **Fast**

Infiltration: **None** Pipe Seal Cond: **Unknown**
